Appendix C Site Inspection Photographs, April 10 and 11, 2006

Institutional Controls at the Stringfellow Superfund Site

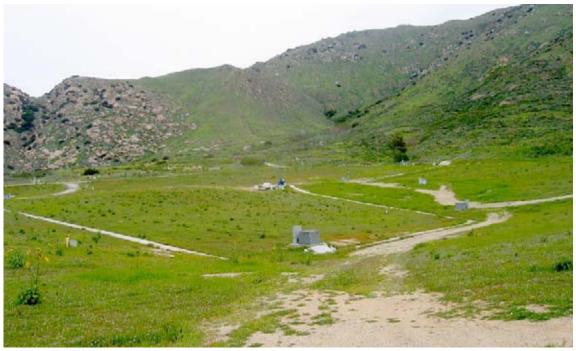
Northern former disposal area in Zone 1. Drainage gutters and extraction wells are visible. Also, well maintenance activities are being performed (center of photo).

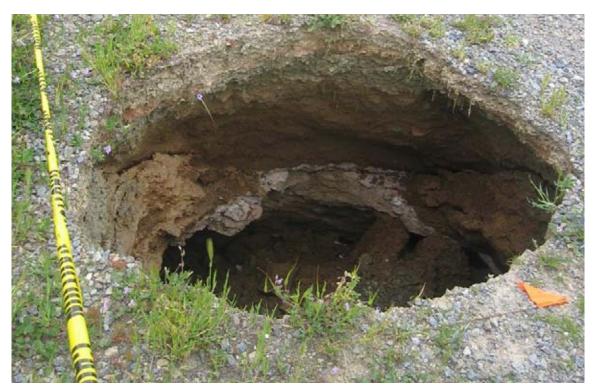
Sinkhole observed at the southwest corner of the northern former disposal area in Zone 1. The sinkhole is approximately 3 feet in diameter and approximately 5-feet deep. The cause of the sinkhole is being evaluated further by DTSC's contractor.

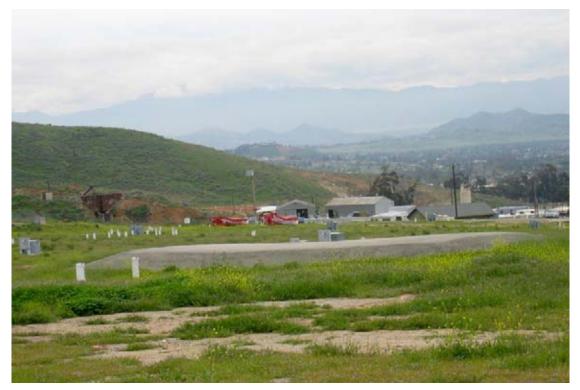
This area within the southern former disposal area in Zone 1 was capped with drill cuttings and asphalt when subsidence was observed in the early 1990s.

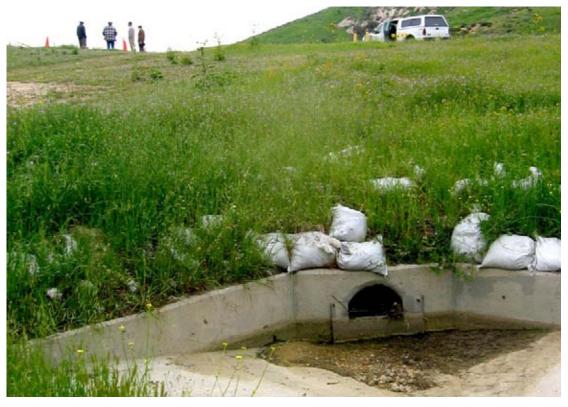
Surface water drainage collection area in northern disposal area in Zone 1. Surface water that drains from the (capped) former pond surface flows from this location to the perimeter drainage channel. Minimal debris was observed.

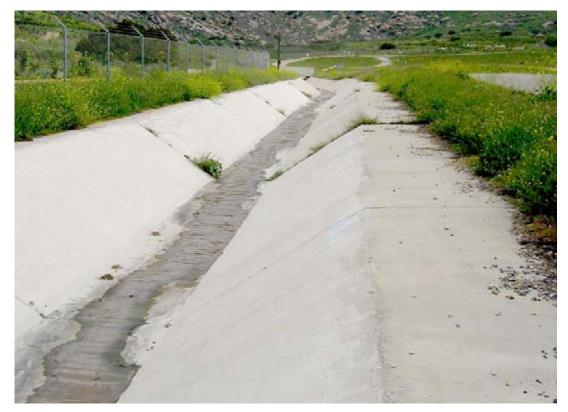
Surface water drainage channel on west side of former disposal area in Zone 1. The channel contains minimal debris and surface water.

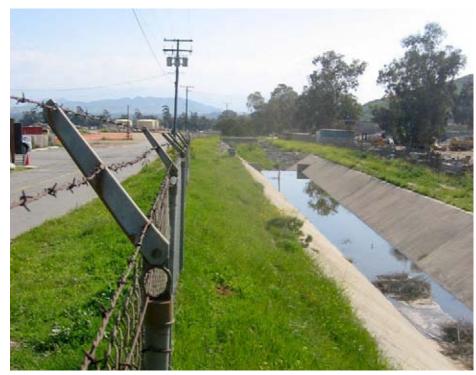
Surface water drainage channel upstream of the weir, showing areas of the channel that are not lined and contain vegetation downstream of the weir.

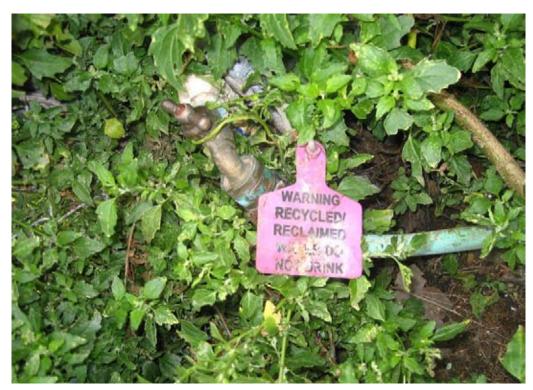
Warning on private wells that provide access to treated water from the Community Wellhead Treatment System in Zone 4. Treated water at these wells is to be used for irrigation purposes only.
